Technical Information Bulletin

Subject: Modification of Link Plate; ADF **BULLETIN NO.: 19503**

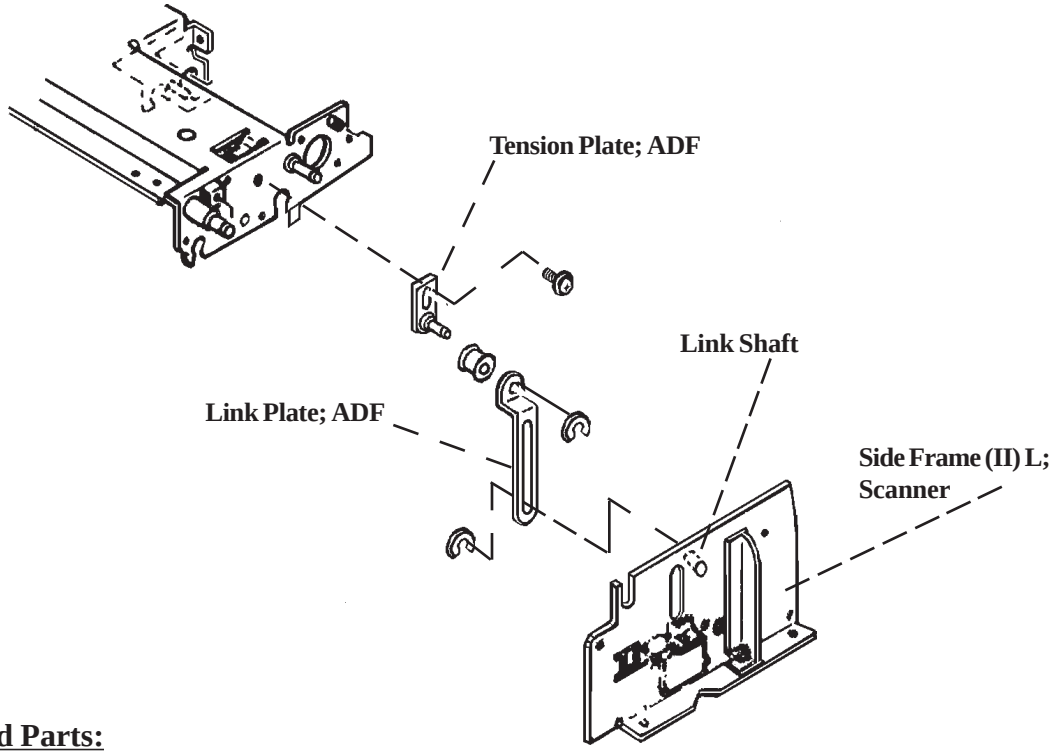
Several reports have indicated that the Link Plate; ADF bends and the ADF unit will not close correctly. This condition may also cause the Original Misfeed (C 36) to occur.

1. Link Plate; ADF - The thickness has been increased from 1.0 mm to 1.6 mm.
2. Link Plate; ADF - The thickness has been increased from 1.2 mm to 1.6 mm.
3. Side Frame (II) L; Scanner - The length of the link shaft has been changed.

If experiencing this problem, the Newly Registered Parts listed below should be used to replace the corresponding parts in the ADF unit. The parts have been improved as indicated.

1. 017-16586-100 Link Plate; ADF
2. 017-16567-105 Tension Plate; ADF
3. 017-16569-302 Side Frame (II) L; Scanner

NOTE: **Changing one part requires changing all three parts.**
